AMMRC TR 85-2

LOW-COST, NET-SHAPE CERAMIC RADIAL TURBINE PROGRAM

D.W. RICHESON and J.R. SMYTH
GARRETT TURBINE ENGINE CO.
A Division of The Garrett Corporation
111 S. 34th St., P.O. Box 5217
Phoenix, AZ 85010

FINAL TECHNICAL REPORT for the Period
February 1981 — December 1984

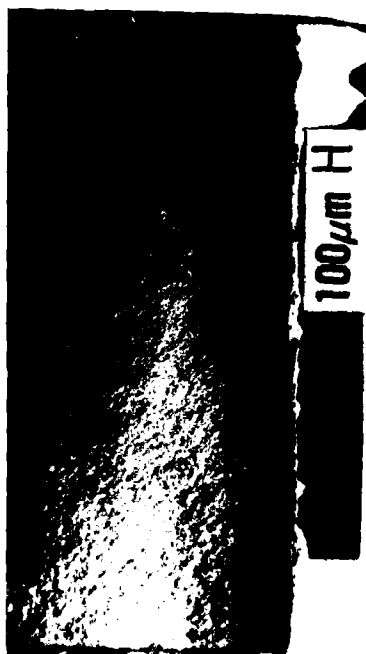
23-SVG1488-7

FRACTURE SURFACE

HIGHER MAGNIFICATION OF
OXIDE SURFACE LAYER

Figure 25. Code 1 Material After 170 Hours/2552F Heat Treatment in Static Air.

*The gold (Au) peaks in Figure 25 are due to the gold coating sputtered on to prevent charging during the SEM and EDX analyses. To avoid the overlap between the gold and yttrium peaks, the Code 13 specimen shown in Figure 26 was sputtered with carbon instead of gold.

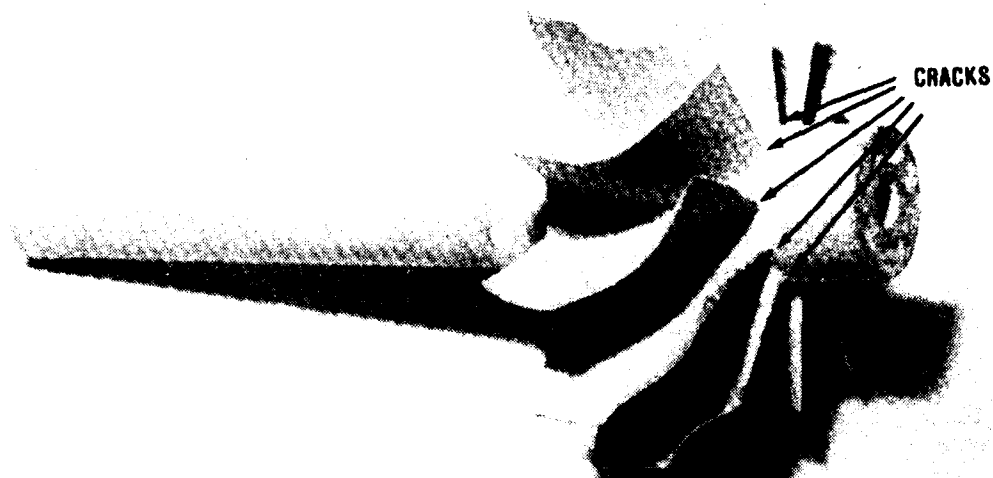
51a. Defect Identified Before Spin Testing.

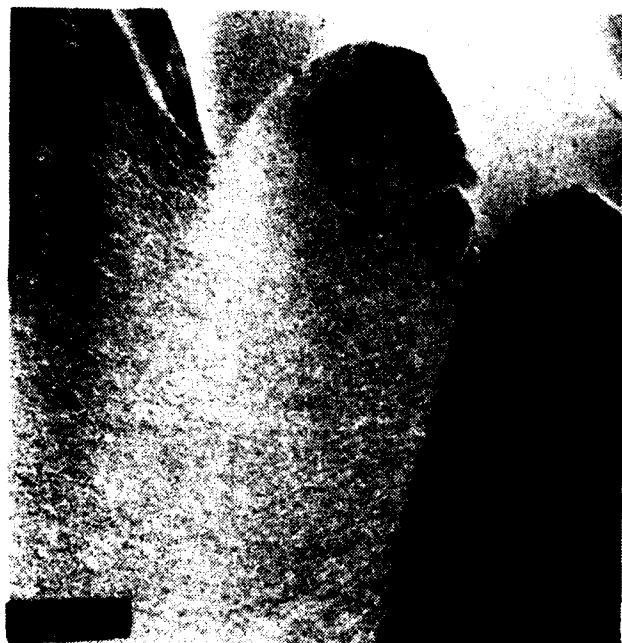
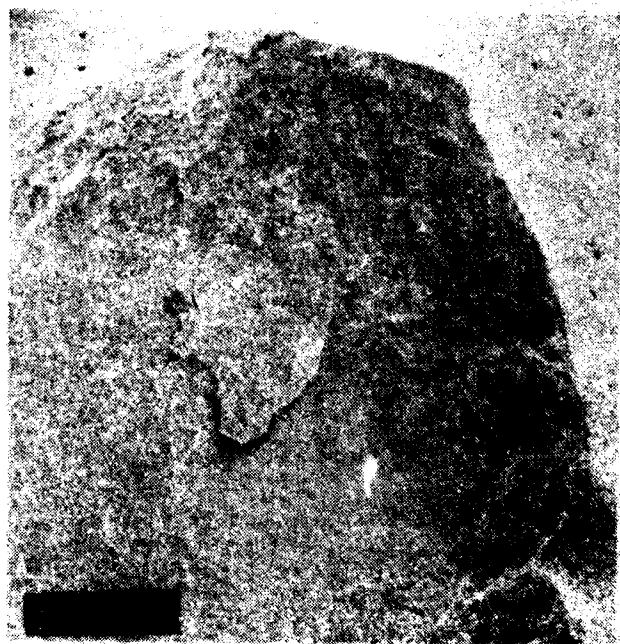
51b. Fracture Origin Identified After Spin Testing.

Initial examination of the failed rotors revealed that each had burst into numerous small pieces. Examination of the
